Keyboard circuit trace restoration using conductive silver paste for computer input devices

Moh Muchlishiin¹, Aprima A Matondang², Cholish³, Thea Fitri Astarani⁴, Haksa Sinambela⁵

^{1,2,3,4,5}Electrical Engineering Technology, Department of Electrical Engineering, Politeknik Negeri Medan, Indonesia

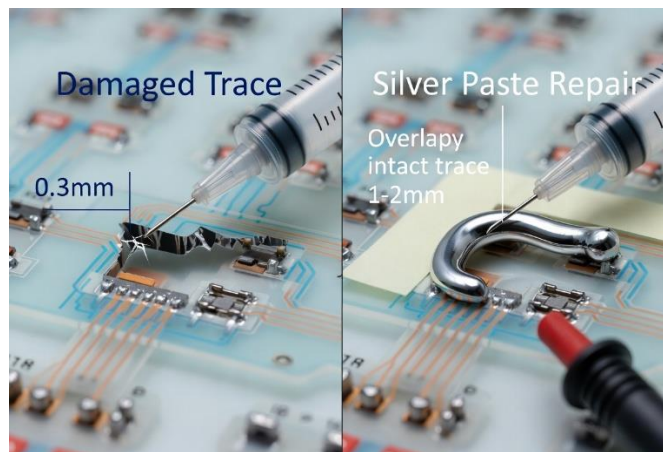
Figure 1. Damage Trace and Silver Paste Repair

Kapton tape was cut using a scalpel to create an aperture matching the original trace width (0.3–0.5 mm). Using fine-tipped tweezers, the mask was positioned so that the aperture bridged the broken section with at least 1–2 mm overlap onto intact trace on each side. The mask was pressed firmly to prevent paste bleeding under the tape (Valdec et al., 2021). This masking technique is critical for maintaining trace isolation and avoiding shorts between adjacent circuits (Zhang et al., 2022).

The silver paste was stirred gently to ensure uniform particle distribution. A 1 mL syringe fitted with a 0.3 mm diameter blunt needle was loaded with approximately 0.2 mL of paste. Using a steady hand and consistent pressure, the paste was extruded along the masked aperture in a single continuous stroke. Target wet thickness was approximately 20–30 μm , which reduces to 10–20 μm after curing (Valdec et al., 2021). Application was performed under magnification (10 \times) to verify complete coverage without air bubbles or gaps (Valdec et al., 2021).

The applied silver paste underwent a two-stage drying process. First, air drying at room temperature for 5–10 minutes allowed initial solvent evaporation and leveled the paste surface. Second, heat curing was performed using a hot air gun set to 120 $^{\circ}\text{C}$, held at a distance of 10–15 cm from the substrate while moving continuously to avoid localized overheating (Purba et al., 2026). Curing duration was 5 minutes, sufficient to achieve maximum conductivity without damaging the PET substrate (heat deflection temperature approximately 150 $^{\circ}\text{C}$). Temperature was verified periodically using an infrared thermometer.

After curing and cooling, the Kapton mask was carefully removed. Visual inspection under magnification confirmed trace continuity, uniform color, and absence of cracks or voids [18, 19]. Electrical testing proceeded in three stages: (a) Continuity test: Multimeter in buzzer mode verified closed circuit across the repaired trace (Hardi et al., 2021). (b) Resistance measurement: Four-wire
